**DeLUCA HOFFMAN ASSOCIATES, INC.
CONSULTING ENGINEERS**

Site Visit Week of: August 30-September 3, 2010		Job No.: 1599.52.02
Project: Saco Central Fire Station		
Location: Saco, Maine		
Contractor: Pizzagalli Corp.	Owner: City of Saco	
Present at Site:		
Joe Newton, DeLuca-Hoffman Associates, Inc.		
G. Richards, Pizzagalli Corp.

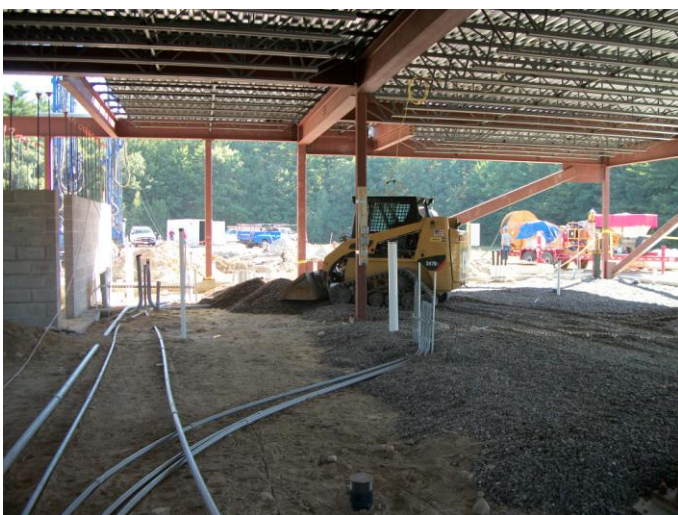
Photo 1 (0076): Shows Peters Construction Co. crew

grading subgrade in the Administrate area floor slab.

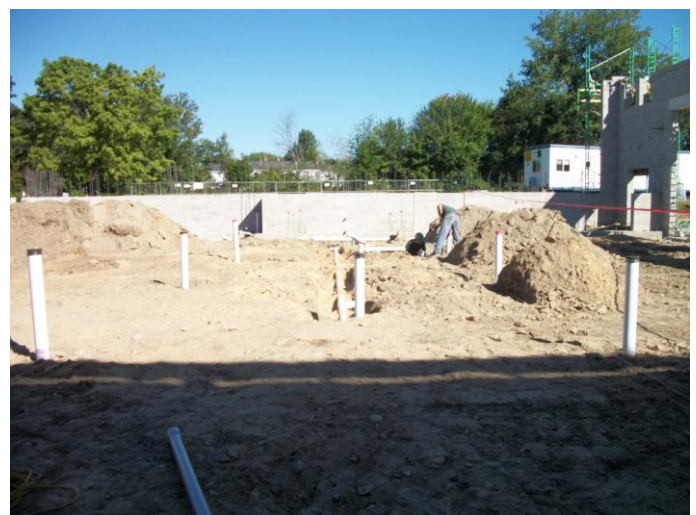
Photo 2 (0078): Shows Titan Mechanical Co. crew

installing sanitary piping in the Apparatus Bay.

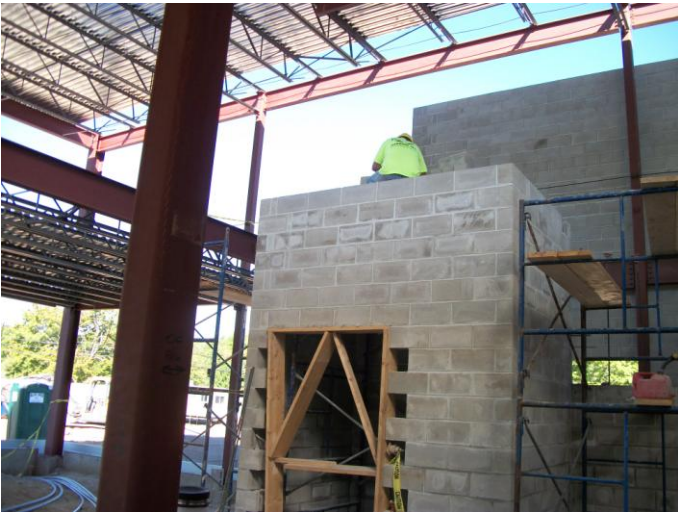
Photo 3 (0075): Shows Nate Libby Masonry Co. crew installing masonry blocks on elevator shaft walls.

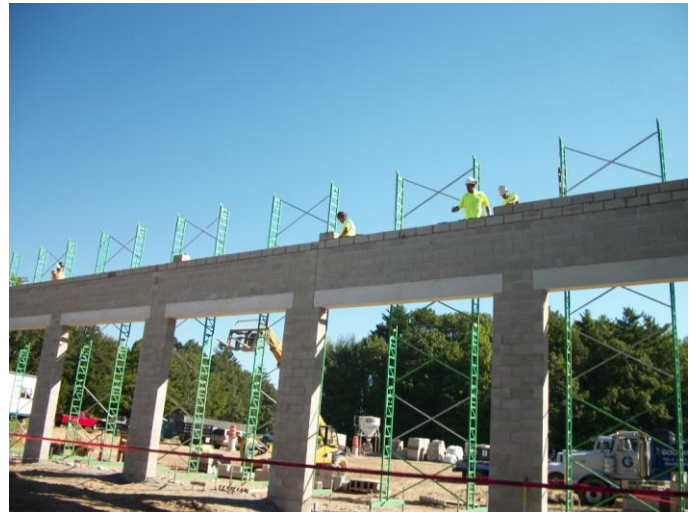
Photo 4 (0077): Shows Nate Libby Masonry Co. crew installing concrete blocks on east wall of the Apparatus Bay.

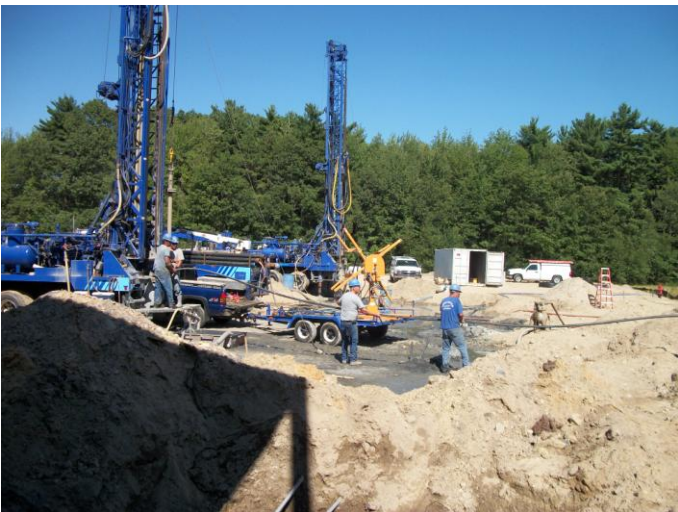
Photo 5 (0084): Shows Goodwin Well Drilling Co. crews reaming out geothermal wells No. 2 and No. 6.

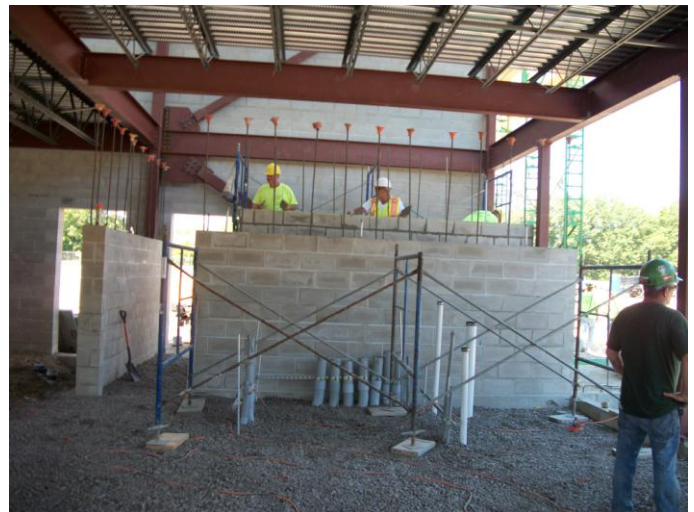
Photo 6 (0083): Shows B.H. Millekin Electric Co. crew providing electrical conduits for installation into masonry stairwell walls.

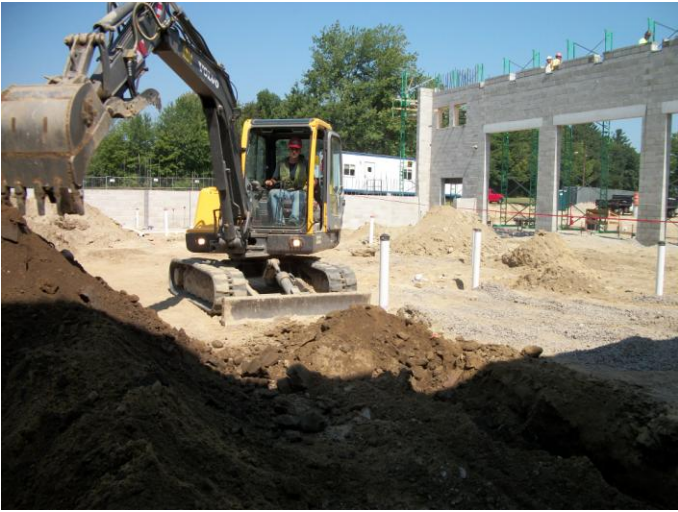
Photo 7 (0115): Shows Peters Construction Co. crew excavating trenches for sanitary piping in the Apparatus Bay.

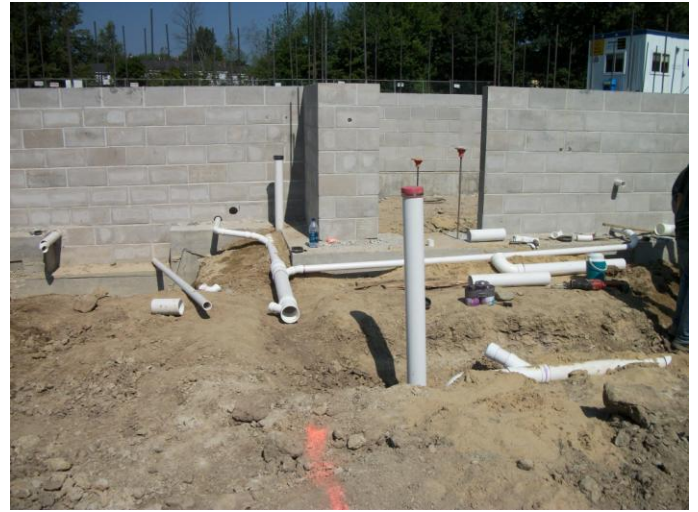
Photo 8 (110): Shows Titan Mechanical Co. crew installing sanitary piping below slab elevation in the Apparatus Bay.

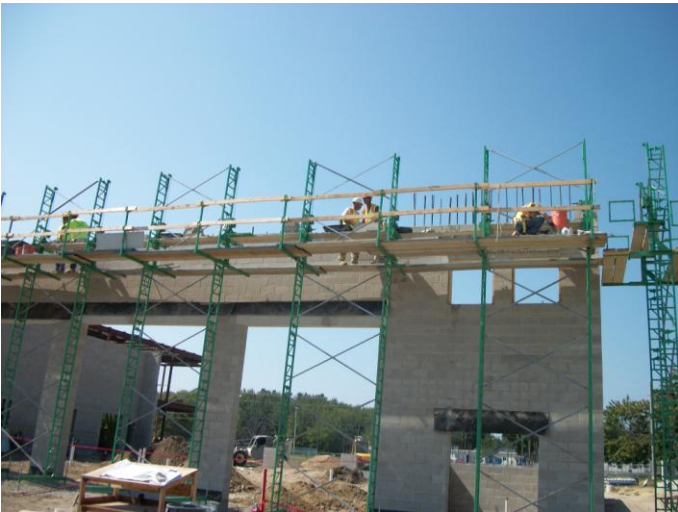
Photo 9 (0108): Shows Nate Libby Masonry Co. crew installing concrete blocks in east wall of the Apparatus Bay.

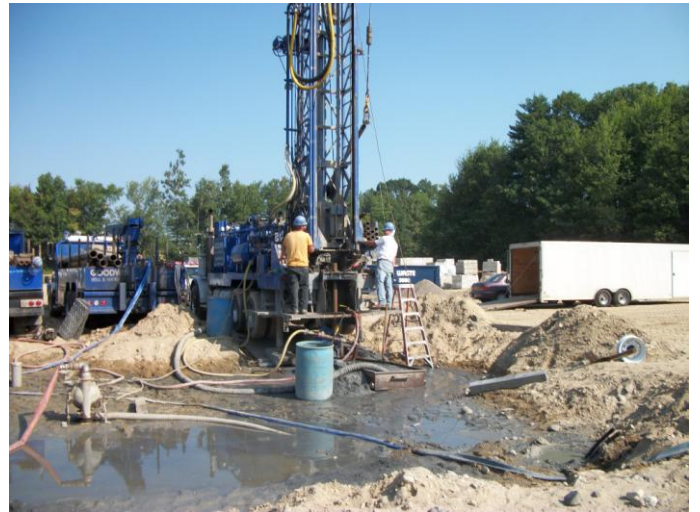
- Goodwin Well Drilling Co. crew reamed out geothermal well No. 5, having some difficulty keeping open, and grouted No. 5. Second crew set-up on well No. 4. Refer to Photo 10 (0107).

Photo 10 (0107): Shows Goodwin Well Drilling Co. crew reaming out geothermal well No. 5 and second crew setting up on well No. 3.

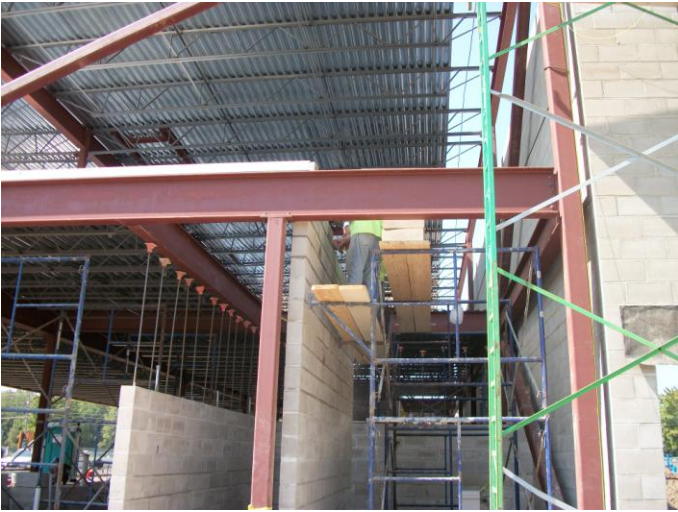
Photo 11 (0109): Shows Davis Erectors Co. crew installing decking on the second floor of the Administration area.

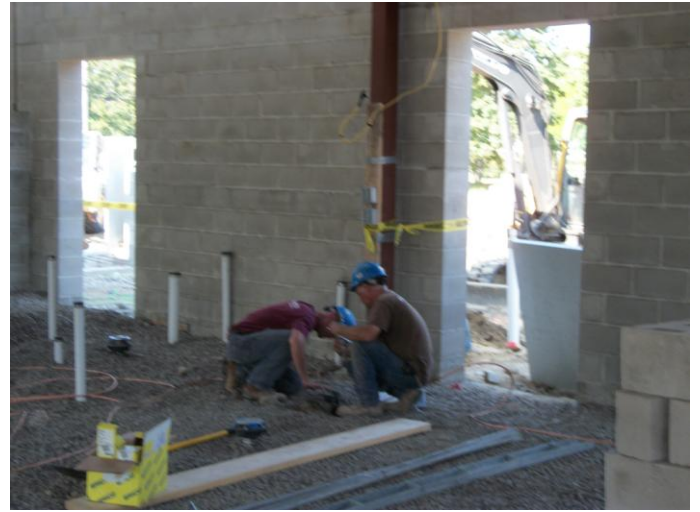
Photo 12 (0114): Shows B.H. Millekin Electric Co. crew installing ground wire and CAD welding to the ground rods in the Administration area of the Fire Station.

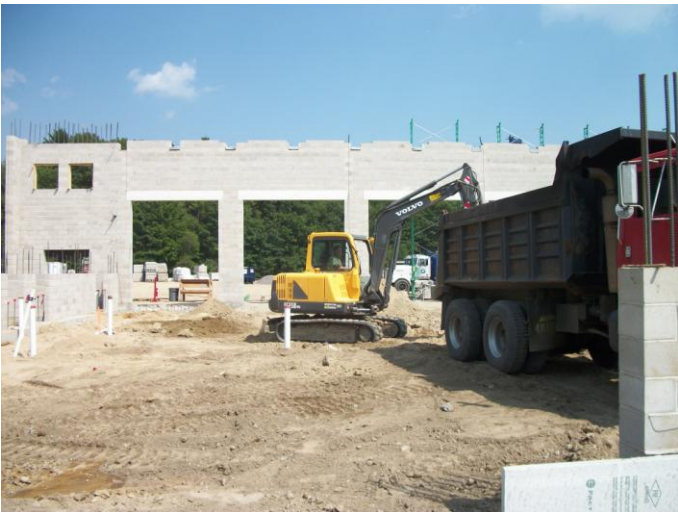
Photo 13 (0139): Shows Peters Construction Co. crew removing excess subgrade materials from the Apparatus Bay area.

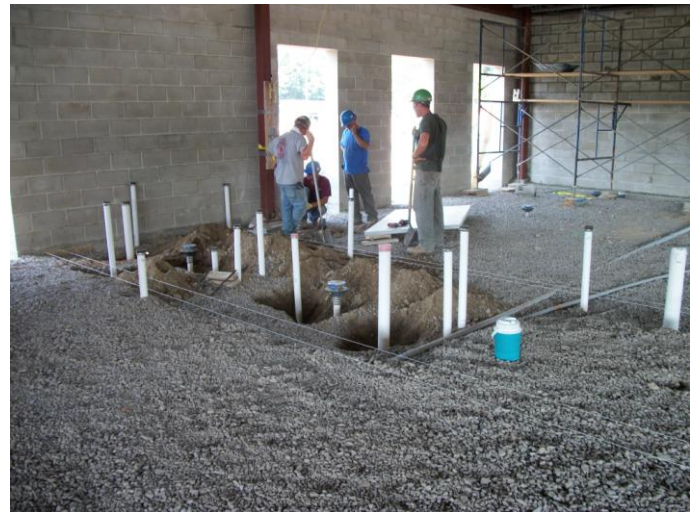
Photo 14 (0140): Shows Titan Mechanical Co. crew relocating under slab sanitary pipe in the Administration area not located correctly.

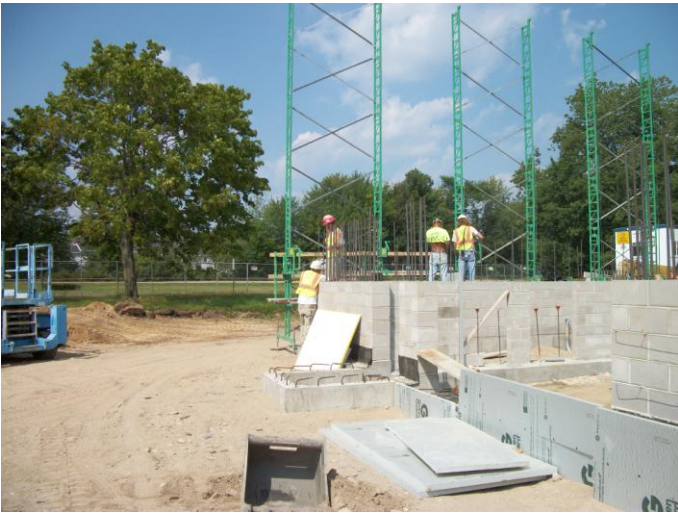
Photo 15 (0138): Shows Nate Libby Masonry Co. crew installing concrete blocks on north wall of the Apparatus Bay.

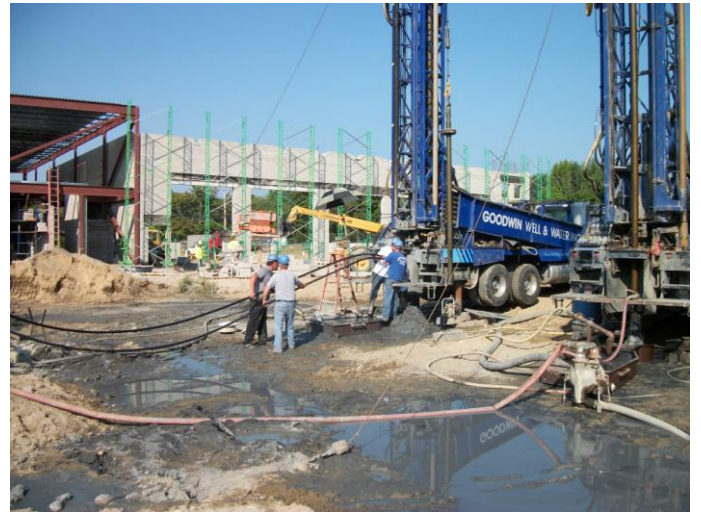
Photo 16 (0126): Shows Goodwin Well Drilling Co. crew reaming out geothermal wells No. 3 and No. 5.

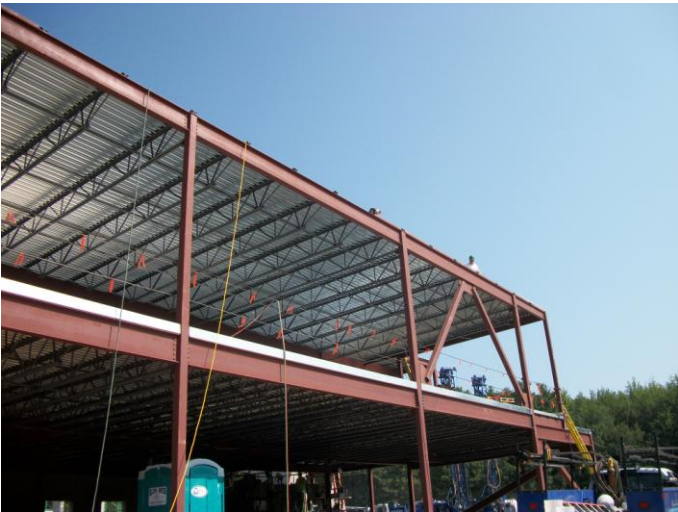
Photo 17 (0132): Shows Davis Erectors Co. crew welding roof decking and concrete stop on second floor decking.

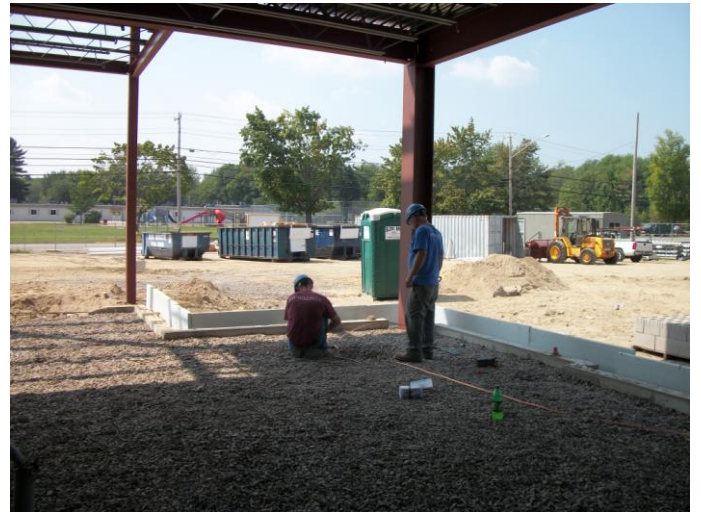
Photo 18 (0136): Shows B.H. Millekin Electric Co. crew CAD welding ground wire to ground rods in Administration area.

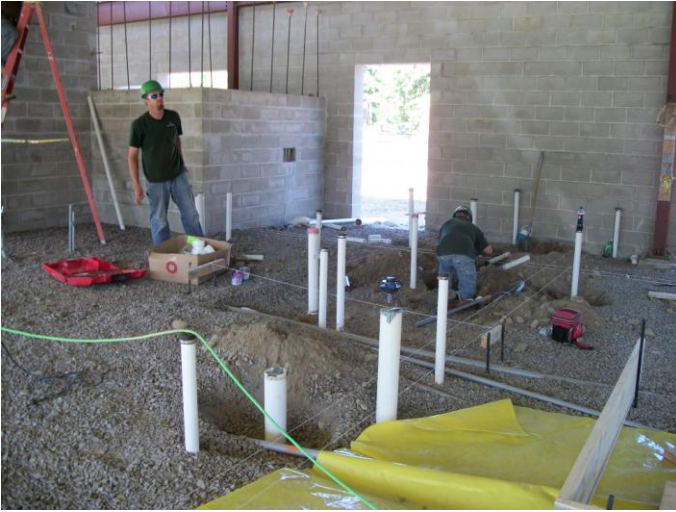
Photo 19 (0152): Shows Titan Mechanical Co. crew relocating bathroom sanitary subslab piping in the Administrative area.

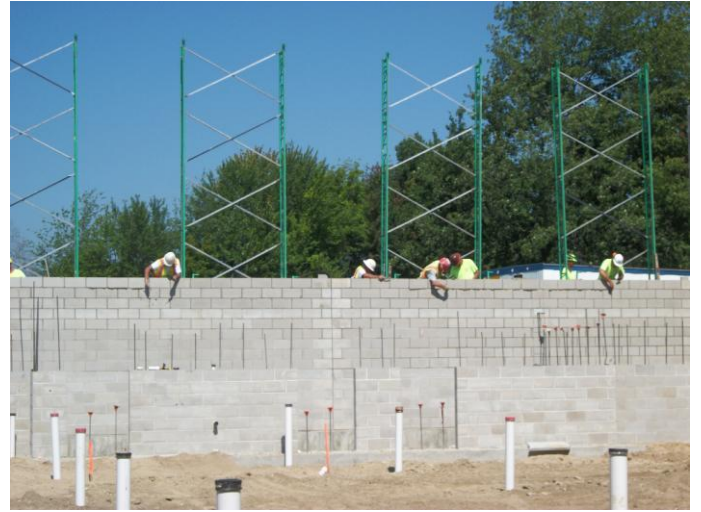
Photo 20 (0156): Shows Nate Libby Masonry Co. crew installing concrete blocks north wall of Fire Station.

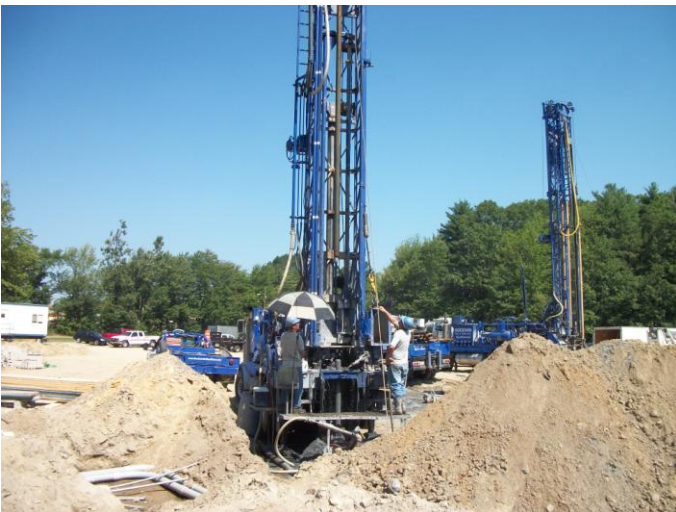
Photo 21 (0150): Shows Goodwin Well Drilling Co. crew reaming out geothermal well No. 6 and No. 1.

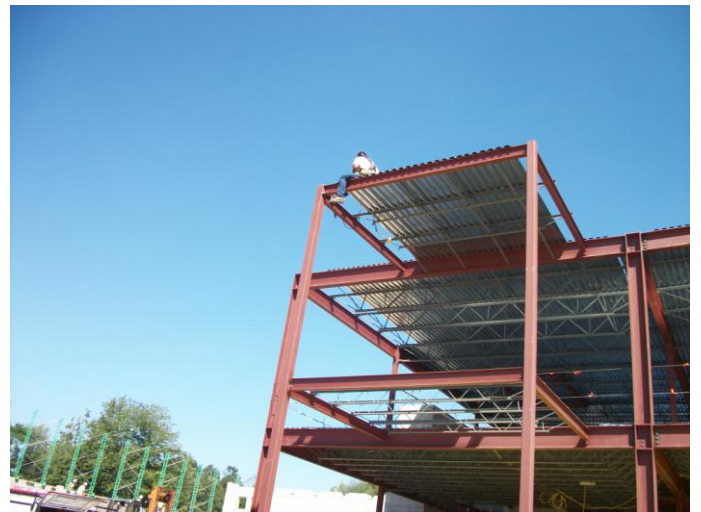
Photo 22 (0159): Shows Davis Erectors Co. crew welding roof decking.

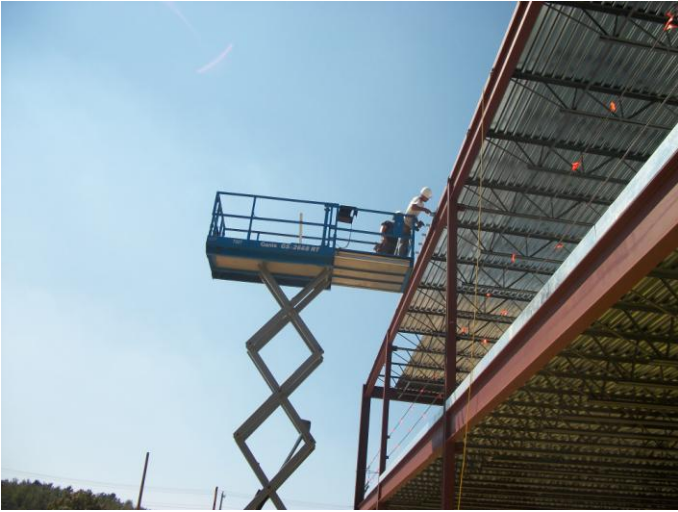
Photo 23 (0158): Shows Dirago Drywall Co. crew installing parapet framing on roof decking area of the Administration area.

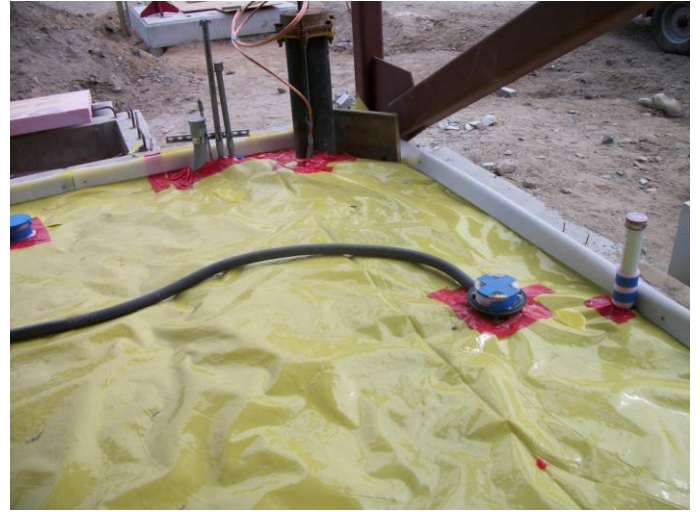
Photo 24 (0166): Shows Titan Mechanical Co. crew installed trap primers to the floor drains in the Administration area.

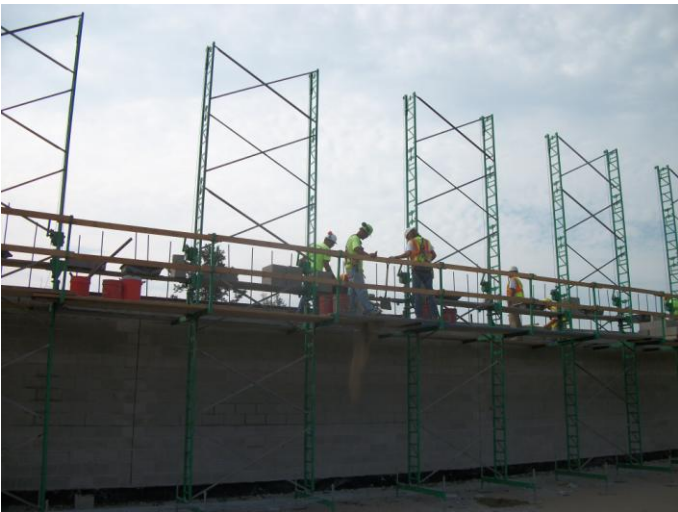
Photo 25 (0162): Shows Nate Libby Masonry Co. crew installing concrete blocks on north wall of the Fire Station.

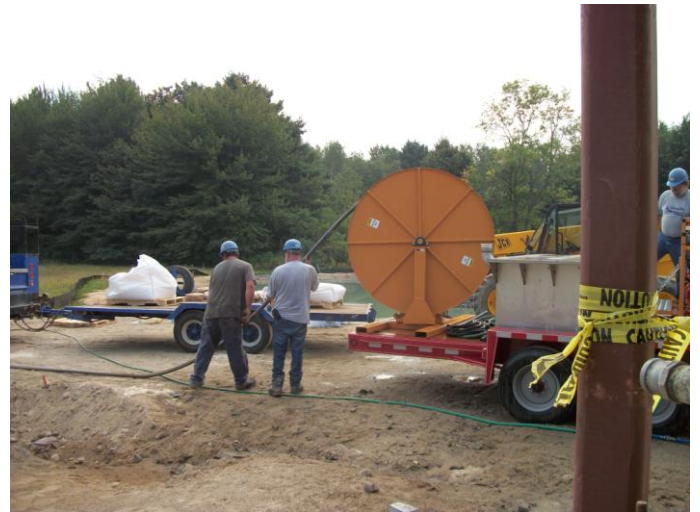
Photo 26 (0163): Shows Goodwin Well Drilling Co. crew installing geothermal piping in well No. 6.

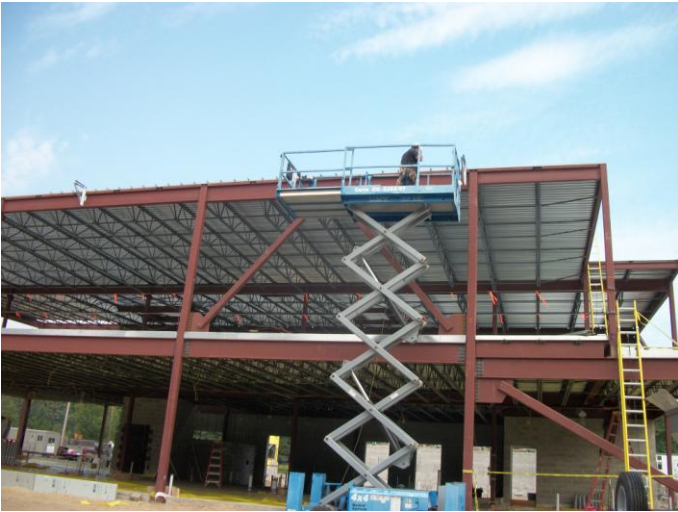
Photo 27 (0164): Shows Dirago Drywall Co. crew installing parapet framing on the roof framing in the Administration area.
