Simpson Road Bridge Update
January 23, 2017

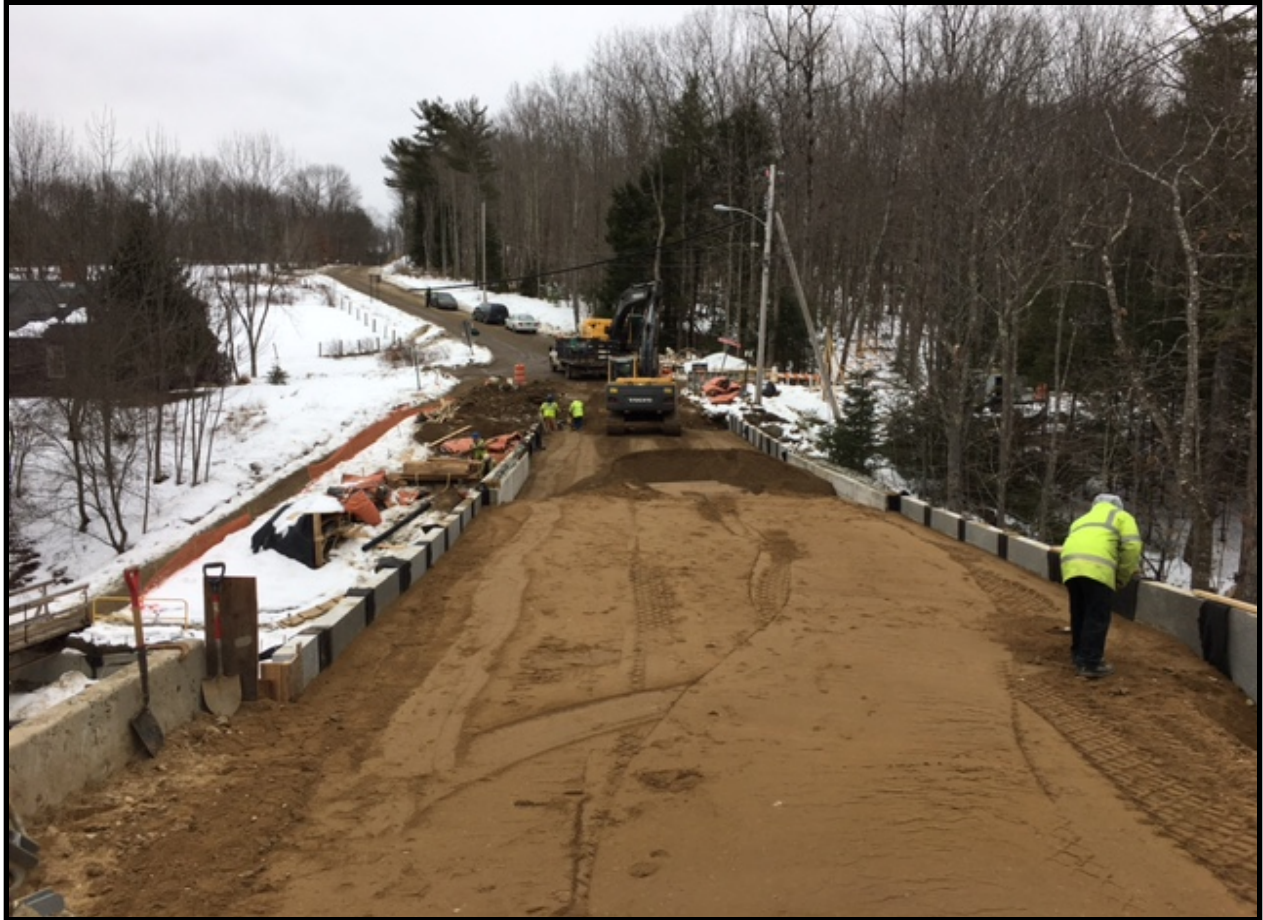
Photo taken on January 23, 2017.

View of Simpson Road bridge crossing over Stackpole Creek from Buxton side looking across bridge towards the Saco approach. Contractor is placing sub base gravel material within the roadway section. Remaining work prior to the end of the month will include installation of Jersey barriers along each side of the roadway to permit re-opening to emergency vehicles.

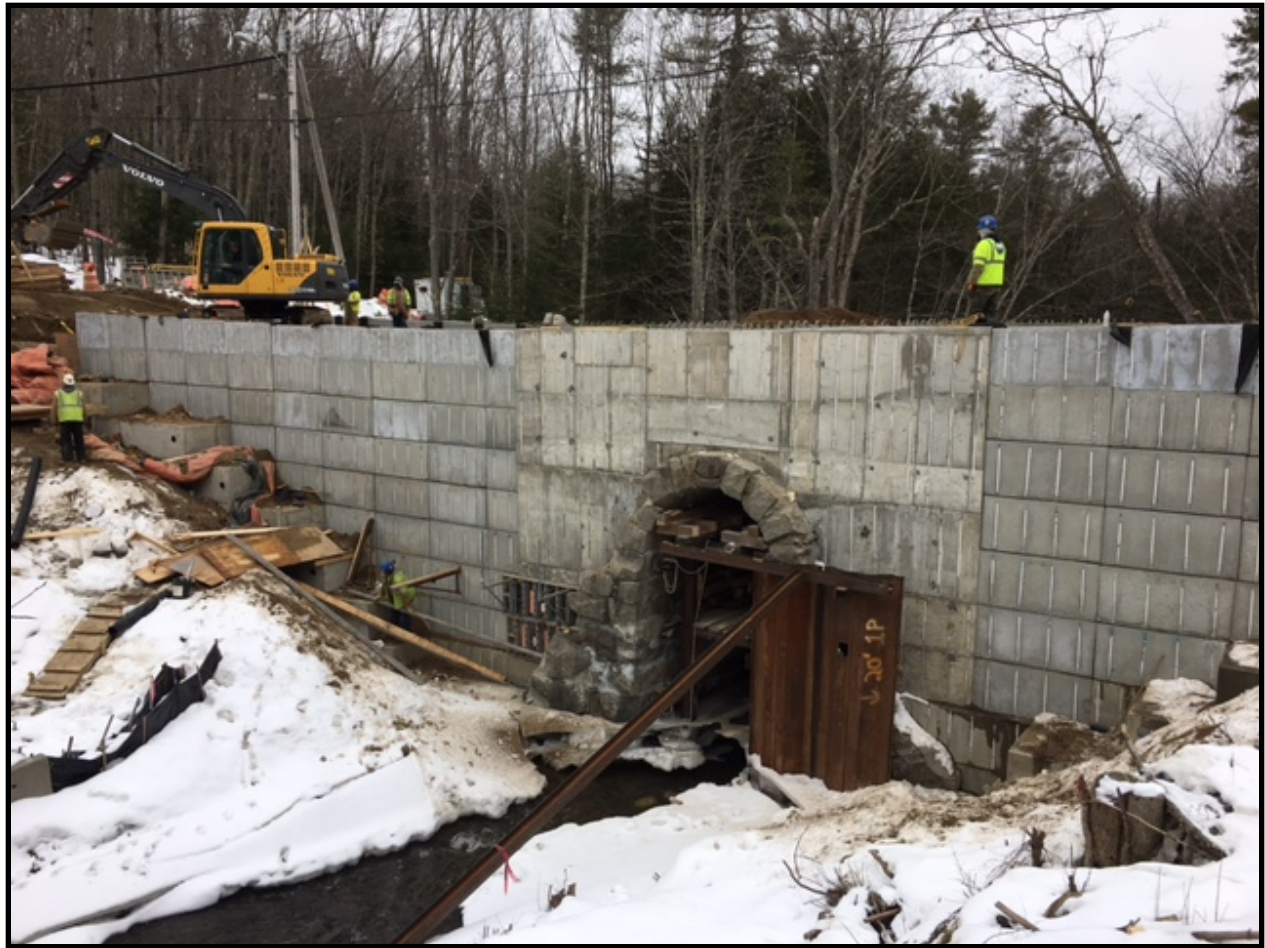
Photo taken on January 23, 2017.

View of upstream side of Simpson Road bridge crossing over Stackpole Creek. Cast-in-place and precast concrete retaining wall structure installation is complete. Remaining work includes installation of masonry veneer exterior surface to match the protruding stones of the key-way arch.
