**DeLUCA HOFFMAN ASSOCIATES, INC.
CONSULTING ENGINEERS**

778 MAIN STREET
SUITE 8
SOUTH PORTLAND, MAINE 04106
TEL. 207 775 1121
FAX 207 879 0896

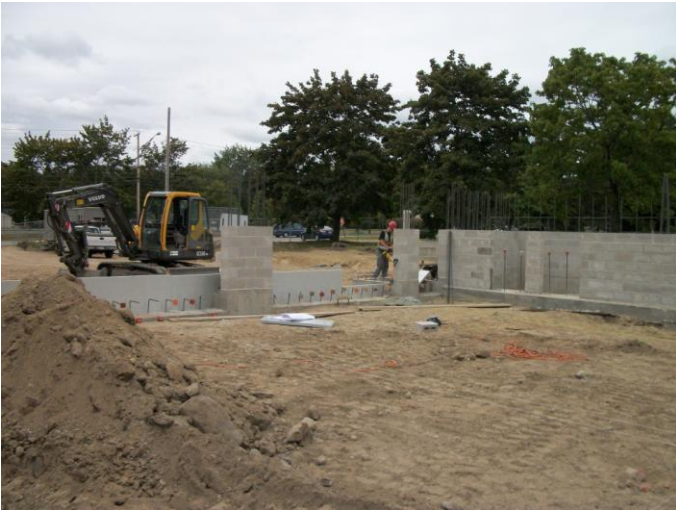
Photo 1 (039): Shows Peters Construction Co. crew installing exterior insulation at the foundation wall of the Apparatus Bay west wall.

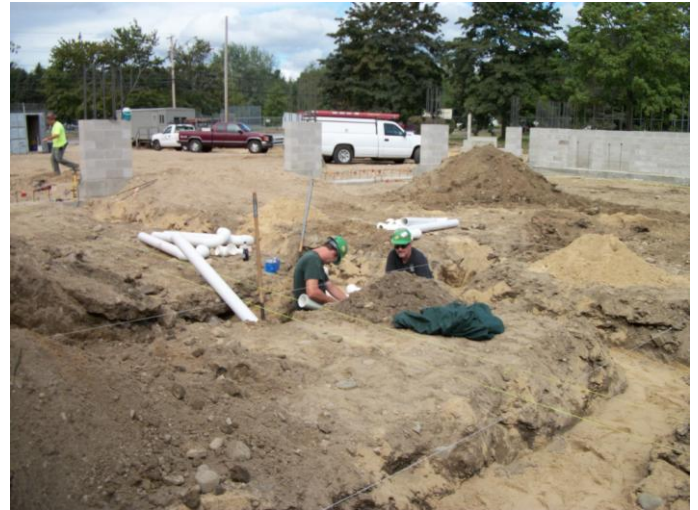
Photo 2 (030): Shows Titan Mechanical Co. crew installing sanitary drain piping below the floor slab in the Apparatus Bay area.
